ENGINEER'S REPORT
of the
JARRED BRYAN SPARKS INCIDENT

By:
Ronald J. Natoli, P.E.
and
Nancy Grugle, Ph.D.

June 26, 2014

Robson Forensic
Engineers, Architects, Scientists & Fire Investigators

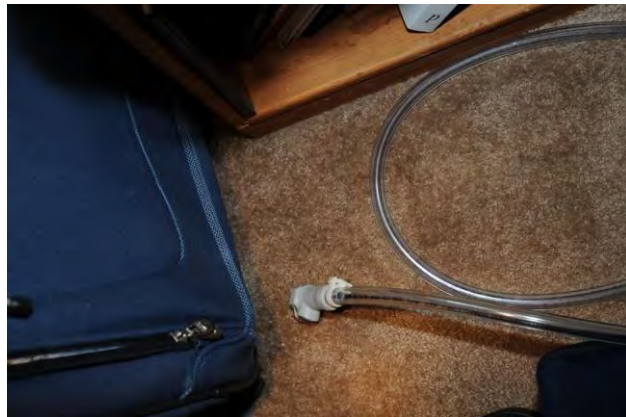
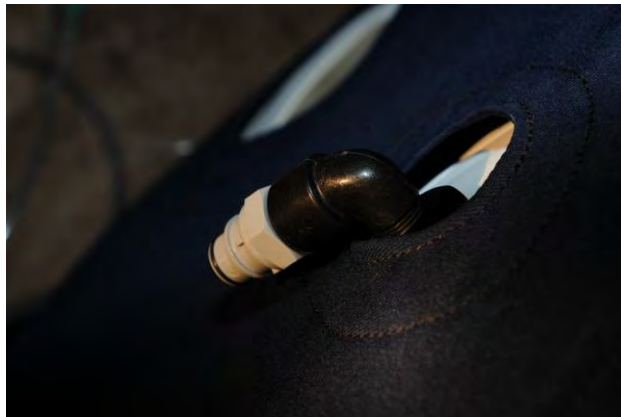
Photo 1

Detective Mincey noted that when he arrived, the air tube that supplies pressure/fresh air to the chamber was disconnected and coiled on the floor (See Photos 1 & 2).

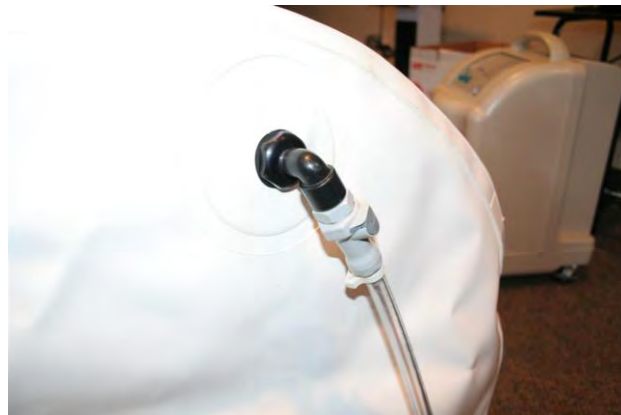
When referring to the quick disconnect connection (see Photo 4 – Jan 8, 2014 inspection photo) supplied with the Oxy Health Vitaeris 320, the detective reported that “the button subsequently was being pressed by the clear plastic container lip” (see Photo 3).

The air hose was connected to the chamber and the unit was pressurized by the detectives. Lieutenant Reyes “touched” the air hose quick disconnect button, the connection disengaged and the hose fell to the floor in a coil as previously noted. The detective’s investigation “revealed that the hose that pumped air into the chamber had a push release button, the hose was located on the back of the chamber, and when the chamber was pushed against the book shelf, the button became pushed by a clear plastic container lip sitting on the bookshelf”. The Detectives concluded that the clear plastic container had inadvertently depressed the release button on the quick release button allowing the critical supply air to the chamber to be disconnected. The loss of the critical supply of fresh air to the chamber would not allow the chamber interior to be maintained at the equilibrium value for carbon dioxide of less than 1% as stated by Oxy Health in the Oxy Health Operating and Reference Guide.

7. Oxy Health's failure to provide threaded style or safety-locking style valve connections on the ventilation/pressurization supply air; or make other design changes to prevent or warn against the inadvertent loss of the required continuous fresh air supply, while operating the Oxy Health Vitaeris 320, was a design defect and was a cause of Jarred Sparks' asphyxiation.

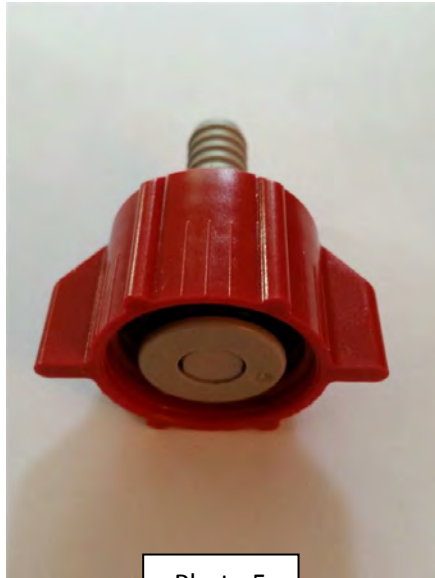
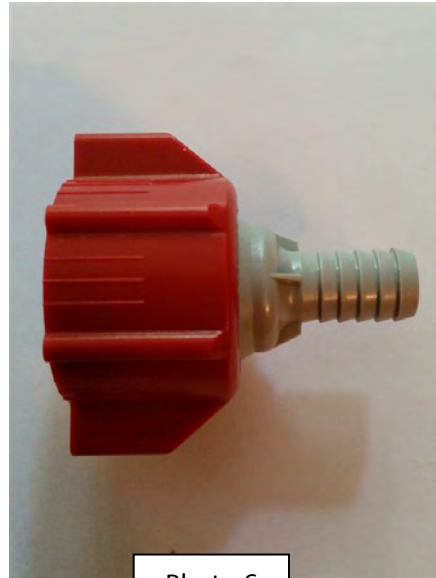
Photo 5

A simple design would have been to incorporate a threaded style connector (see Photos 5 & 6). This style connector is available readily in a "valved" body and "valved" insert configuration similar to quick disconnect style currently being used on the Oxy Health Model Vitaeris 320 hyperbaric chamber.

Unlike the incident quick disconnect valve currently being used, the threaded valve requires 2-1/2 to 3-1/2 full turns of the valve ring to disengage the spring loaded connection. And like the existing quick disconnect valve, connections are made quickly, easily and without the use of tools. The use of a threaded style valved connection would have minimized the risk of an inadvertent release of the critical supply air connection.

Without the use of a positive locking or threaded style connector, the Oxy Health Model Vitaeris 320 hyperbaric chamber was defective, unreasonably dangerous, unsafe for its intended use, and a cause of Jarred Sparks' asphyxiation.

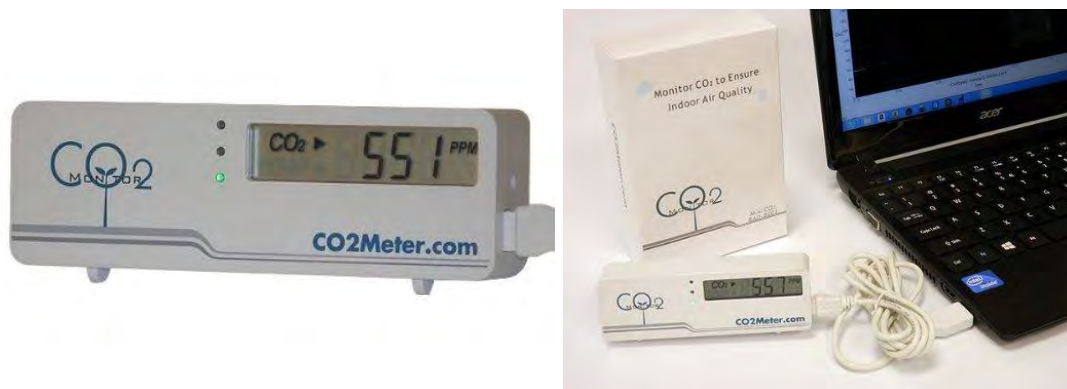
Figure A

Although, carbon dioxide monitoring is only required during saturation operations, which is not part of the operation sequence of the Oxy Health Model Vitaeris 320 hyperbaric chamber, NFPA recognizes the importance of monitoring and maintaining good breathing air quality. Carbon dioxide monitors and alarms are readily available in basic stand-alone or remote monitoring configurations. Many have adjustable warning levels and can also log carbon dioxide levels over time and download the information to a computer. One such simple solution, which is sold for \$109, is shown in figure A:

Oxy Health had a responsibility to identify hazards associated with the Oxy Health Model Vitaeris 320 hyperbaric chamber and to provide guarding to minimize the risk of injury. It would have been easy for Oxy Health to provide guarding that would have monitored the carbon dioxide (CO₂) levels within the chamber and also alarmed in the event that elevated carbon dioxide levels within the hyperbaric chamber were detected. Through the use of a simple carbon dioxide monitor, Oxy Health should have alerted the Sparks of a hazardous condition and prevented the carbon dioxide levels from reaching a dangerous level.

Without the use of a guard (carbon dioxide monitoring system), the Oxy Health Model Vitaeris 320 hyperbaric chamber was defective, unreasonably dangerous, unsafe for its intended use, and a cause of Jarred Sparks' asphyxiation.
